**Minnesota Pollution  
Control Agency**

# UST Cathodic Protection System Evaluation Galvanic (Sacrificial Anode) Type Underground Storage Tanks (UST) Program

Name: Morning Star Market  
Address: 104 North Main Street  
City: Wahkon MN Zip code: 56386  
County: Miller Lacs Phone: \_\_\_\_\_

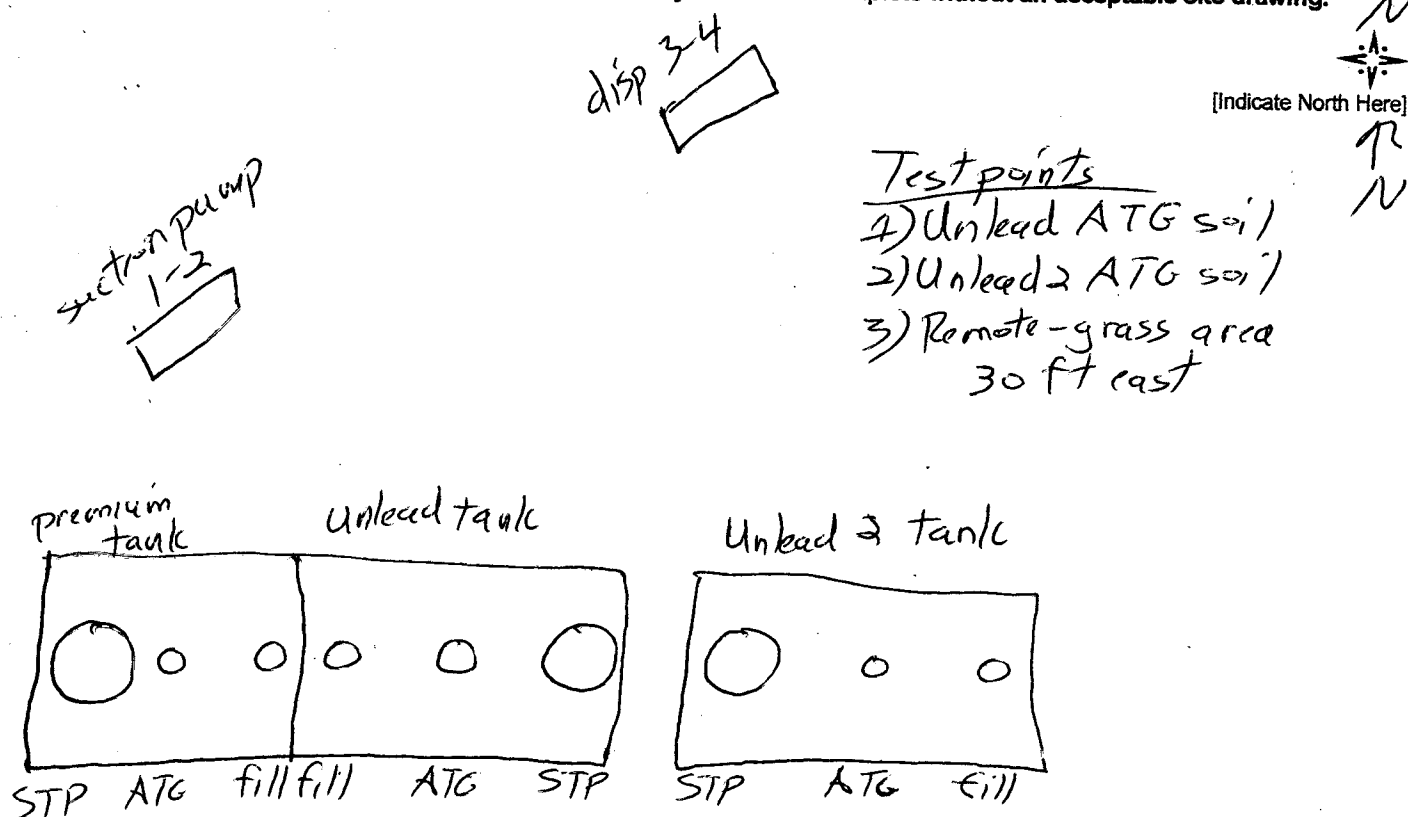
# 12. UST facility site drawing

Attach detailed drawing or use the space provided to draw a sketch of the UST and CP systems. At a minimum you should indicate the following: All tanks, piping and dispensers; Location of anodes if known; All buildings and streets; Location of CP test stations; Each reference cell placement (local and remote) must be indicated by a code (e.g., 1,2, T-1,) corresponding with the appropriate test in Section 10 of this form. If supplemental anodes are added to the tank system, indicate number, size, location and depth of the new anodes. **An evaluation of the CP system is not complete without an acceptable site drawing.**
